The Load PATH

A roof's chain of strength is only as good as its weakest link.

by Richard C. Schroter

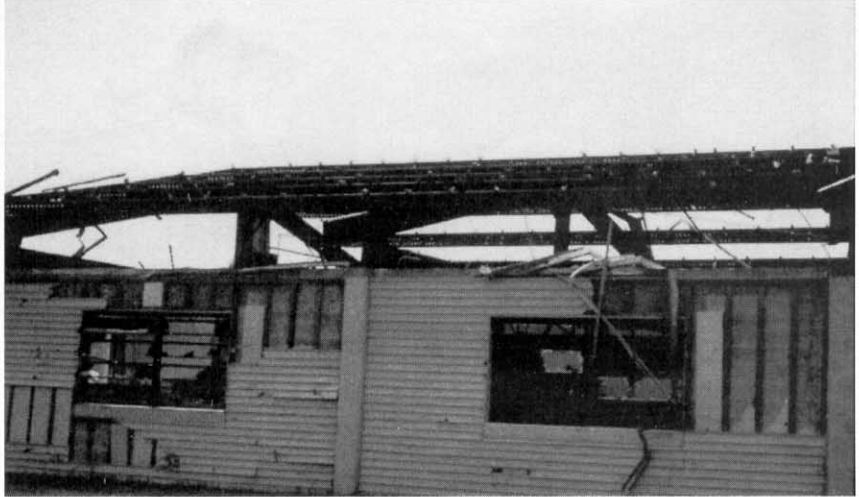
Photo 1.

In *Photos 1* and *2*, taken in Dade County after hurricane Andrew, the clip-to-panel connection of a concealed-fastener SSR system proved to be the weakest link. *Photo 1* shows the walls and frame battered but still secure, with roof panel clips and tabs in place. Only the cladding has been blown away. Clips and tabs are clearly evident on the purlins in these photos.

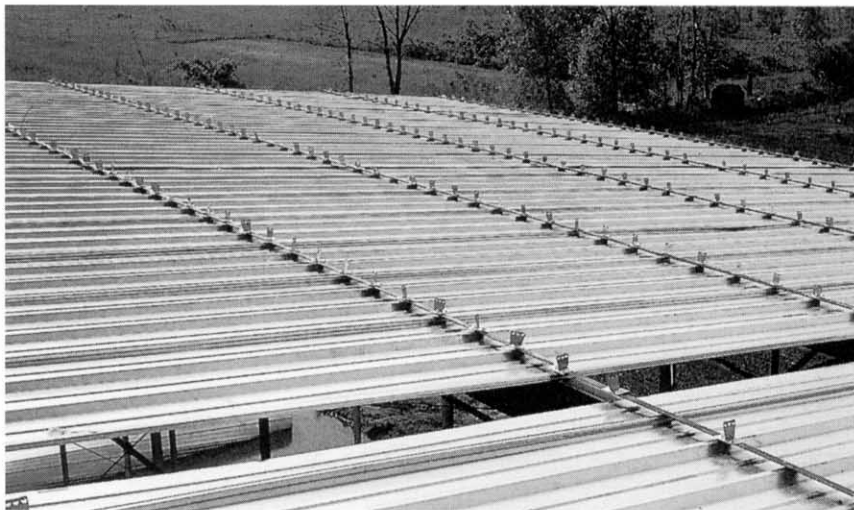
Photo 3.

Photo 3 shows a similar situation in Detroit, Michigan. The one-piece clips show little distress after the roof cladding failed at the gable end and just peeled away.

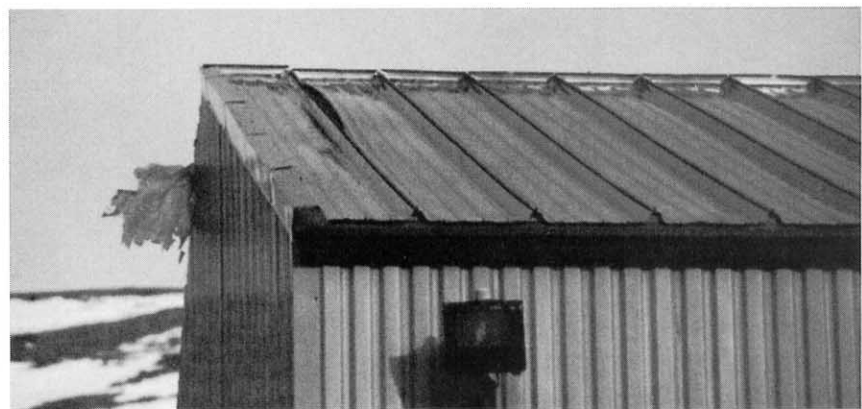
Photo 5.

The type of failures illustrated in these five photos will not show up in computations or in tests of insufficient length panels. As *Photo 5* suggests, end effects can extend 2.4 m or 3 m (8 ft or 10 ft) from an end condition. In ASTM E1592, the minimum specimen length for panels having both ends stiffened is 7.3 m (24 ft).

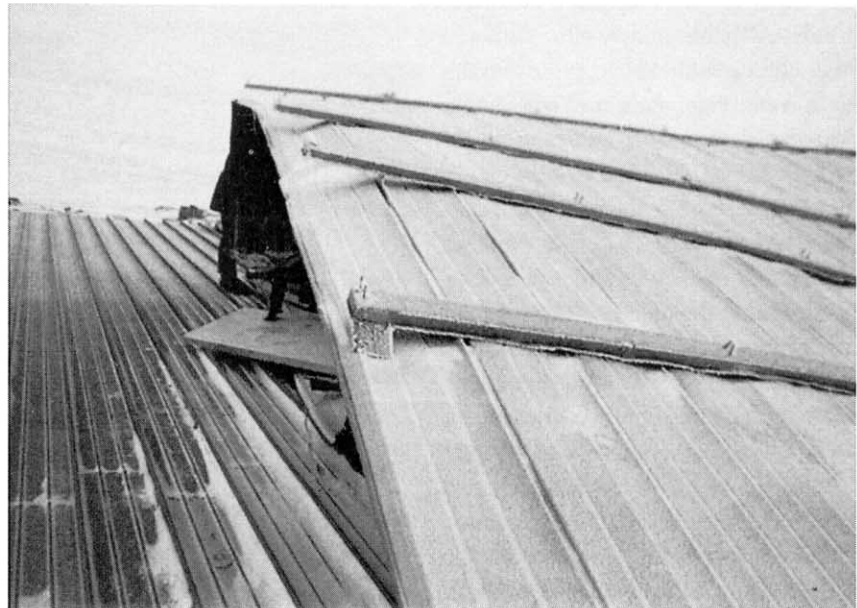
Photo 7.

Purlin anchorage. When purlins are made of wood, connections may be overlooked in the design or assigned an inadequate factor of safety. In *Photo 7*, page 72, purlin anchors were two 10d nails. Spaced in a grid at 1.3 m (4 ft 3½ in.) in each direction, they supported 1.71 m² (18.4 ft²). Nails are not recommended for use in pullout. Based on design values in the *National Design Specification for Wood Construction for Hem-Fir*, the allowable uplift would be less than 0.2 kPa (4 psf). Since the ultimate capacity is less than 1.0 kPa (20 psf), it is understandable that the project did not survive its first winter.

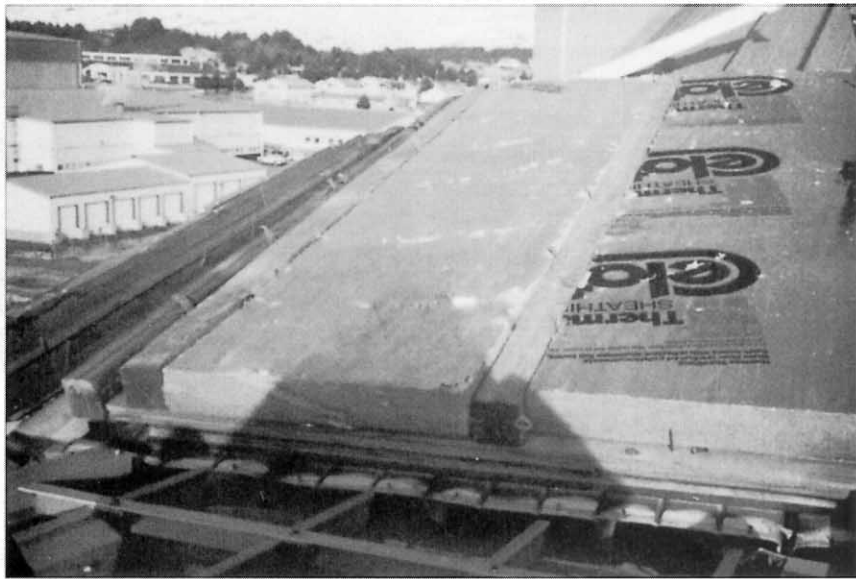
Photo 8.

Reroofing has its own considerations, as the damage to an Alaskan hangar shown in *Photos 8* and *9* illustrates. During an energy-saving retrofit, two layers of insulation and a new metal roof were installed over an existing 40-year-old, 2 x 6 tongue-and-groove wood deck. The original corrugated metal cladding was secured on close centers to the

deck. The structural design was primarily based on snow loads. Wind uplift was not a major consideration. The actual stresses were spread more or less evenly to the deck and then to the steel purlins below. The structure is uniform throughout. At the time of the original design, no code provision existed for higher loads at perimeters or corners.

The retrofit consisted of two layers of rigid insulation between wood members at right angles to each other to produce staggered joints. This type of assembly avoids through-cracks that would compromise the insulation's effectiveness. Purlins in the top layer run crosswise to the slope, providing clip anchorage at 1.3 m centers. These

are secured to sleepers that run parallel to the slope and are secured to the deck with hat-shaped straps at 0.6 m (2 ft) centers. While maintaining the snow load capacity, this configuration effectively reduced the uplift capacity by a factor of four because the sleeper anchors omit six of the eight planks in each section of deck.

In two storms approximately one year apart, about 6 m (20 ft) wide portions of the cladding ripped away from the corners of the structure, pulling out a pair of 2 x 6s every 1.2 m (4 ft) or so. The missing deck sections clearly illustrate where the load path was weakest. The location of the failures also supports the importance of accounting for higher uplift in corner zones.
