Tech Spec 7

Interlocking Concrete
Pavement Institute

Repair of Utility Cuts Using Interlocking Concrete Pavers

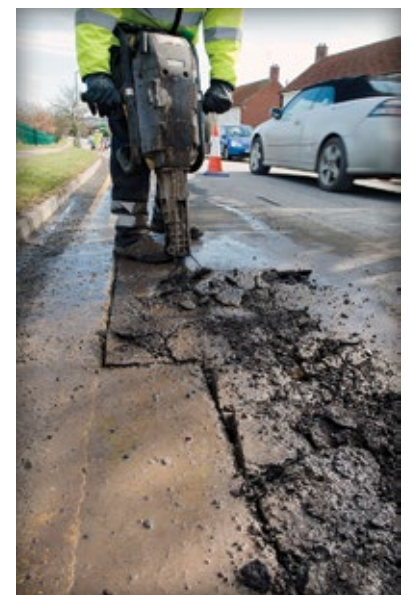
Figure 1. Repairs to utilities are a common sight in cities, incurring costs to cities and taxpayers.

North American cities have thousands of utility cuts made in their streets each year. Figure 1 shows a daily occurrence in most cities: repairs to underground utility lines for water, sewer, gas, electric, steam, phone, fiber-optic, or cable services. A sample is given below of the number of annual utility cuts in a few cities.

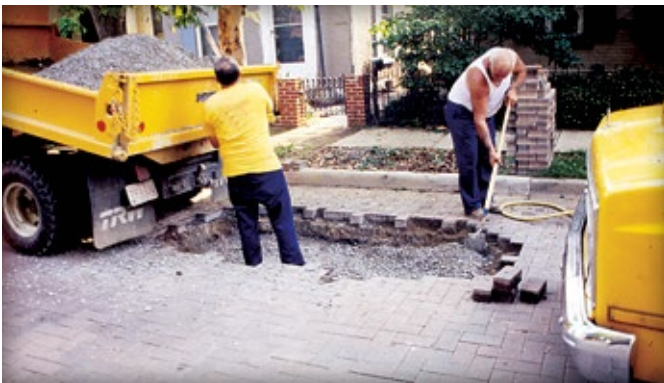
Figure 2. Removal of concrete pavers for a gas line repair in Dayton, Ohio.

Figures 2, 3, 4, 5 and 6 show the process of repair and illustrate the continuity of the paver surface after it is completed. The reinstated units are knitted into existing ones through the interlocking paving pattern and sand filled joints. Besides providing a pavement surface without cuts, the joints distribute loads by

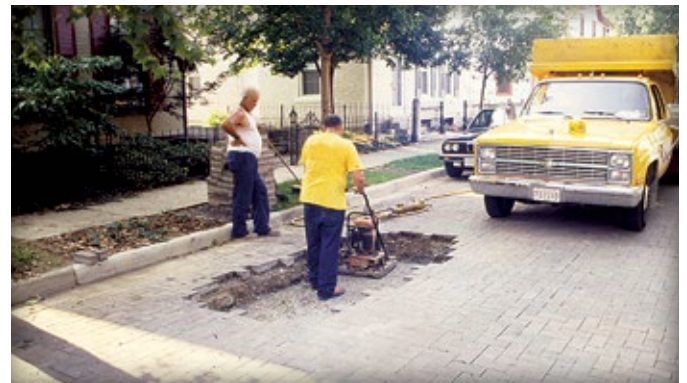
Figure 3. Compaction of the base

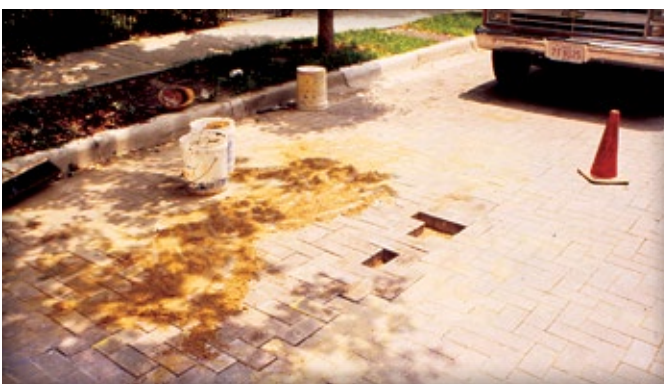
Figure 4. Reinstatement of the pavers, bedding and joint sand

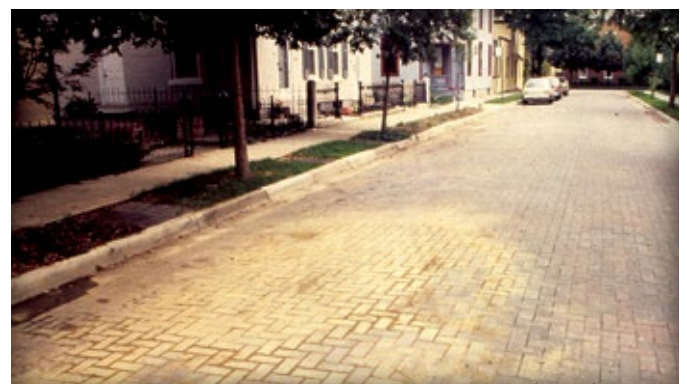
Figure 5. The final paver surface is continuous. There are no cuts or damage to the pavement.

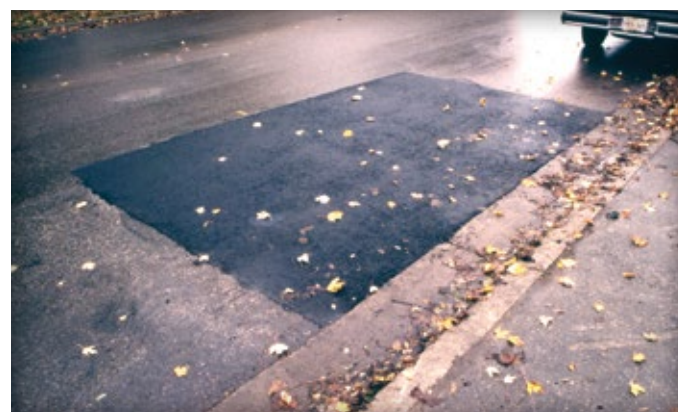
Figure 7. Pavement damage from settlement and shrinkage of cold patch asphalt.

Figure 7 shows the result of settlement and shrinkage of the cold patch asphalt in a London, Ontario, utility cut. The change in dimensions causes the edge of the cut asphalt to deteriorate, and settlement decreases riding quality.

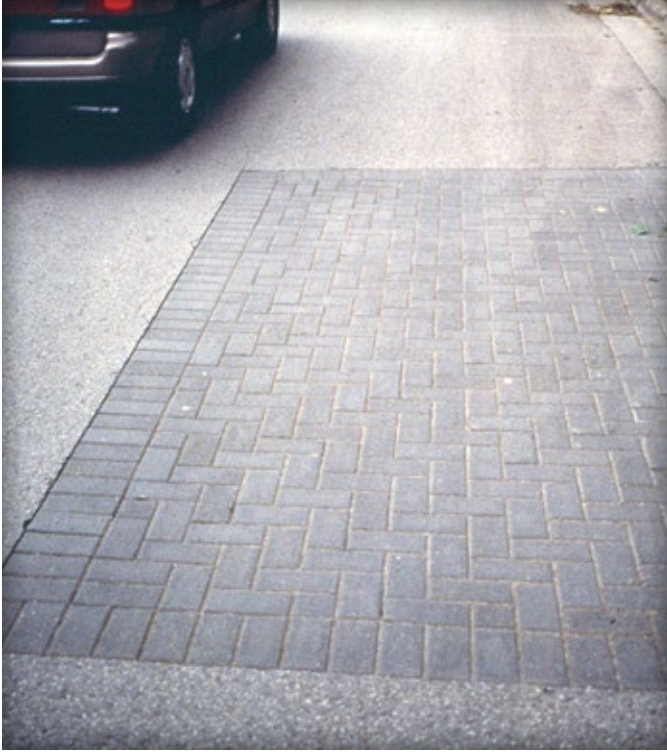
Figure 8. Utility cut repair in a residential area in London, Ontario.

Concrete pavers on low density concrete fill have been successfully used as a replacement for cold patch asphalt (Figures 8 and 9). They were first used as a temporary repair with the intent of being removed in the spring. However, the pavers performed so well that the City of London left them in place indefinitely. Several repairs were in streets subject to heavy truck traffic, as well as residential streets. Costs were less than using cold patch asphalt.

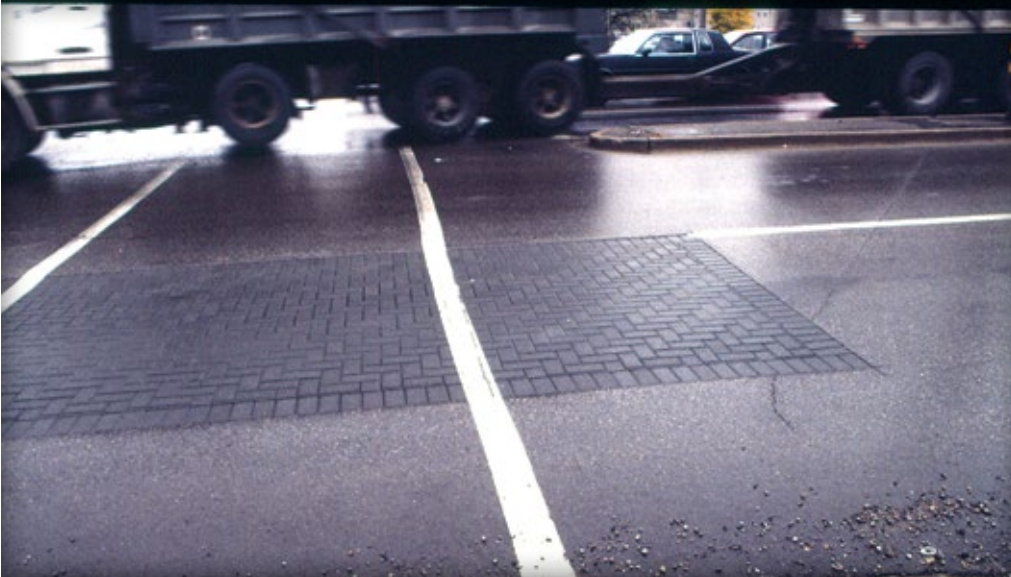
Figure 10. A patch of pavers in a heavily trafficked intersection in London, Ontario

to match the appearance of the asphalt so there would be no substantial differences in appearance. Figure 10 shows such a patch of pavers blending with the surrounding pavement.

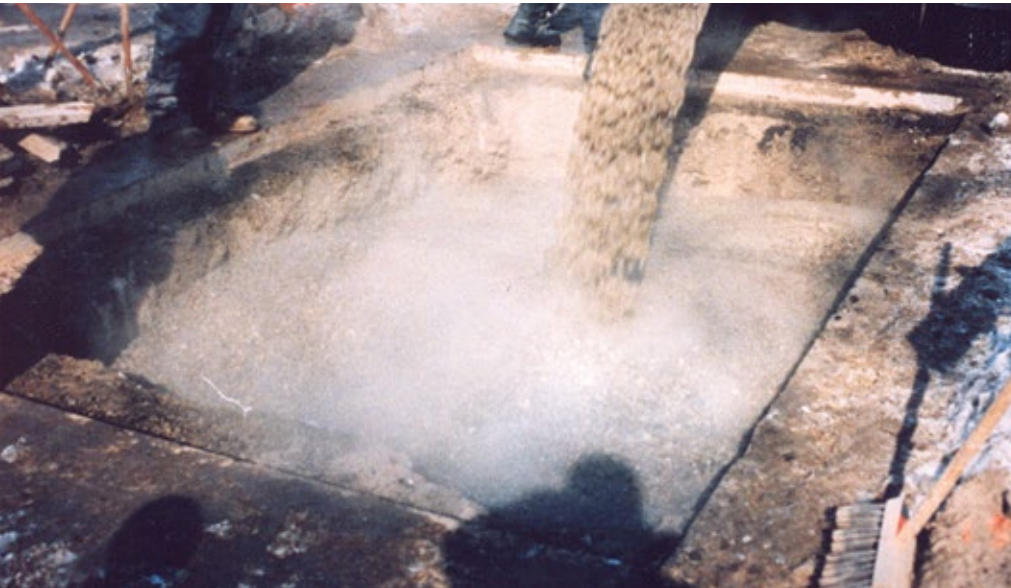
Figure 11. Low density concrete fill (unshrinkable fill) poured into a utility trench from a ready-mix concrete truck.

Unshrinkable fill poured into the trench is shown in Figure 11. The fill flows into undercuts, under the edge of the cut asphalt (providing additional support), and in places where the soil or base has fallen from the sides of the trench. These places are normally impossible to fill and compact with aggregate base or backfill material.

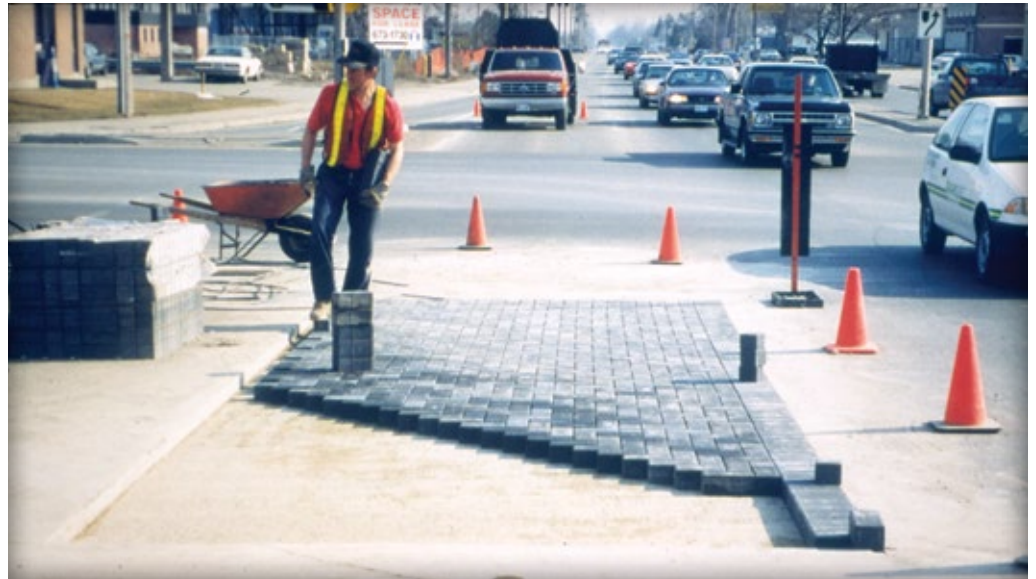
Figure 12. Pavers are laid in a 90 degree herringbone pattern between the border courses.

ers [nominally 4 in. by 8 in. (100 mm x 200 mm)] should be placed against the cut asphalt sides as a border course. They should be placed in a sailor course, i.e., the long side against the asphalt. No cut paver should be smaller than one third of a unit. Place pavers between the border course in a 90 degree herringbone pattern (Figure 12). Joints between pavers should be between $\frac{1}{16}$ and $\frac{5}{16}$ in. (2 to 5 mm). Compact the pavers with a minimum 5,000 lbf (22 kN) plate compactor. Make at least four passes with the plate compactor. A small test area of pavers may need to be compacted to check the amount of settlement. The bedding sand thickness should

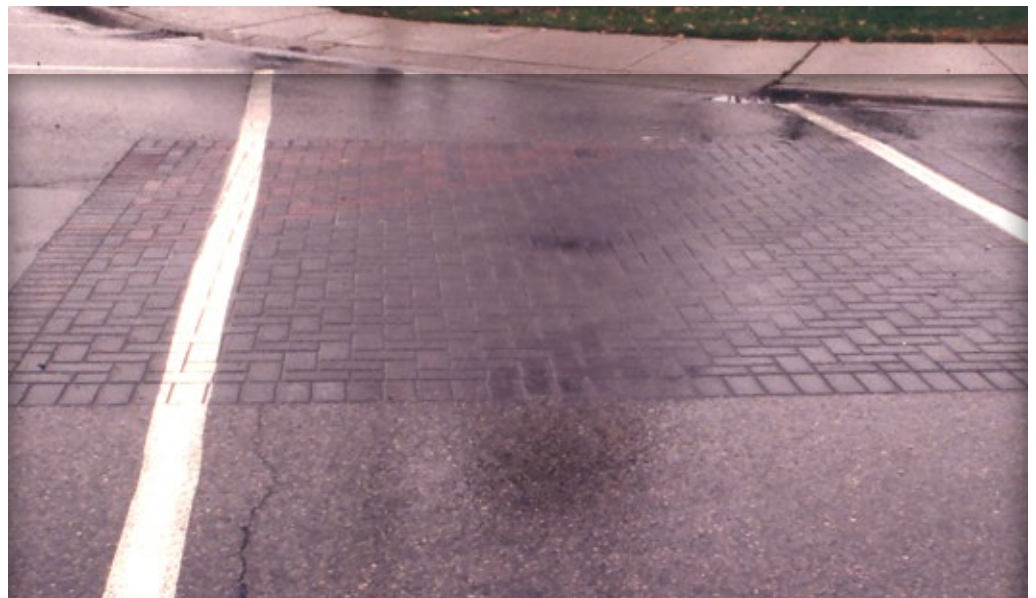
Figure 13. Concrete pavers in utility cuts can be painted as any other pavement.

Spread, sweep and compact sand into the joints. The joint sand is typically finer than the bedding sand, and should conform to the grading requirements of ASTM C 144 (11) or CSA A179 (10). The joints must be completely full of sand after compaction. Remove excess sand and other debris. The pavers may be painted with the same lane, traffic, or crosswalk markings as any other concrete pavements (Figure 13).
